Airfield Damage Repair Modernization Program

AM2 3-4 Alternate Lay Pattern Evaluation

September 2014

Final report

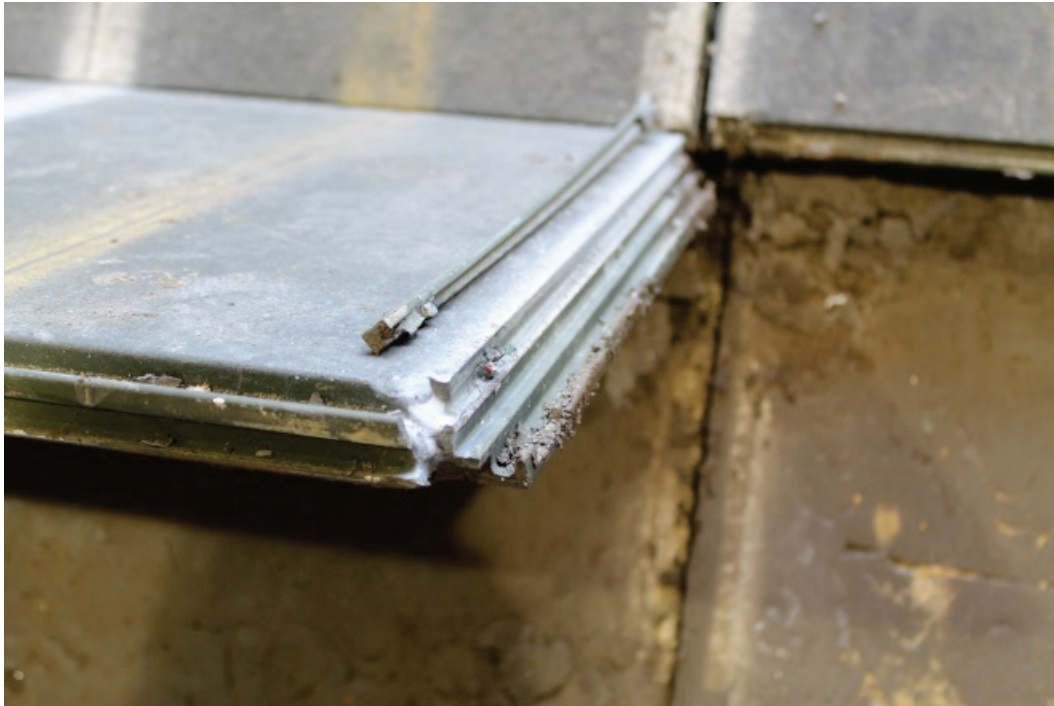
Figure 32. Typical broken upper underlap rail.

Trafficking of the F-15E test item began on May 9, 2013. During the first 50 passes, significant bow-wave movement was observed in the region of instrumented panels where six consecutive longitudinal joints were installed. No mat panel damage was observed until the upper underlap of the end connector on Panel 62 separated from the mat after 62 passes, as shown in Figure 32. At this point, Panel 62 was failed. Trafficking was continued. After 69 passes, the upper underlap separated from Panel 69, and it was failed. The same failure mechanism was observed in Panel 78 after 71 passes. All three of these panels were installed consecutively, and the failures were successive. The failures continued to progress, and Panel 84 failed by a broken upper underlap after 120 passes; Panels 92 and 98 were noted to have failed after 135 passes. Since there was no support along the traffic centerline for 12 ft of test section length along these failed panels, trafficking was stopped after 136 passes, and testing on the F-15E item was concluded.

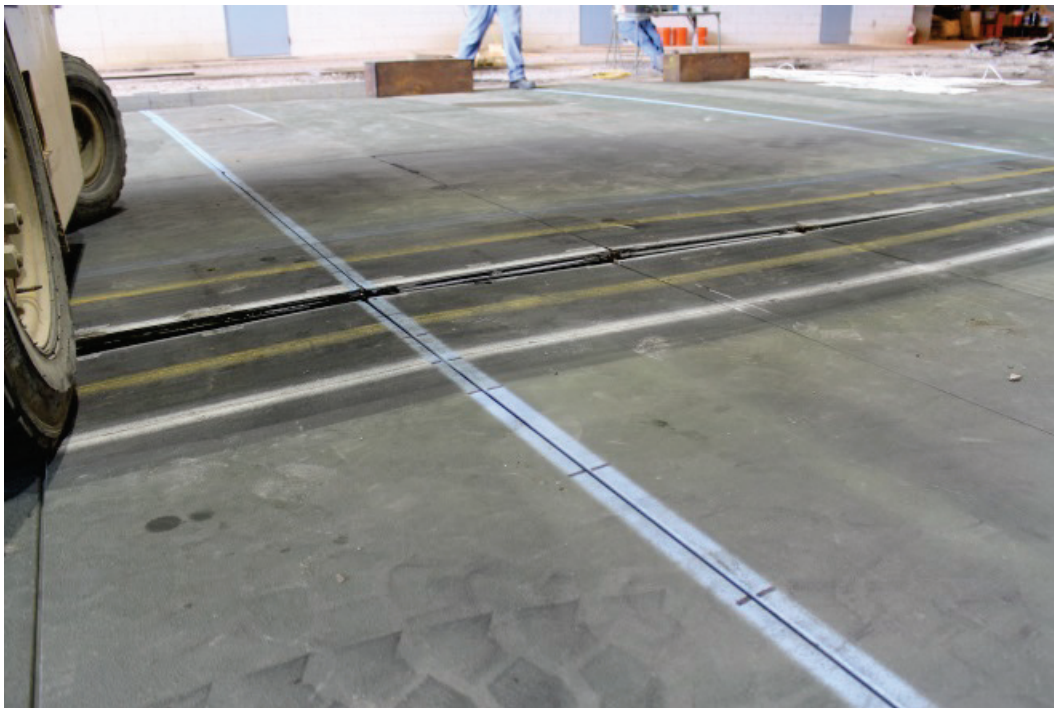
Figure 33. Six successive panel rail failures where joints were continuous.

Figure 33 shows the successive panel failures along the centerline with a forklift parked on the surface. At this point in the test, four 12-ft panels and two 6-ft panels had failed, equaling 12% of the test item. Therefore, the test item failed due to mat breakage, and trafficking was terminated to prevent instability of the load cart and damage to the aircraft tire.

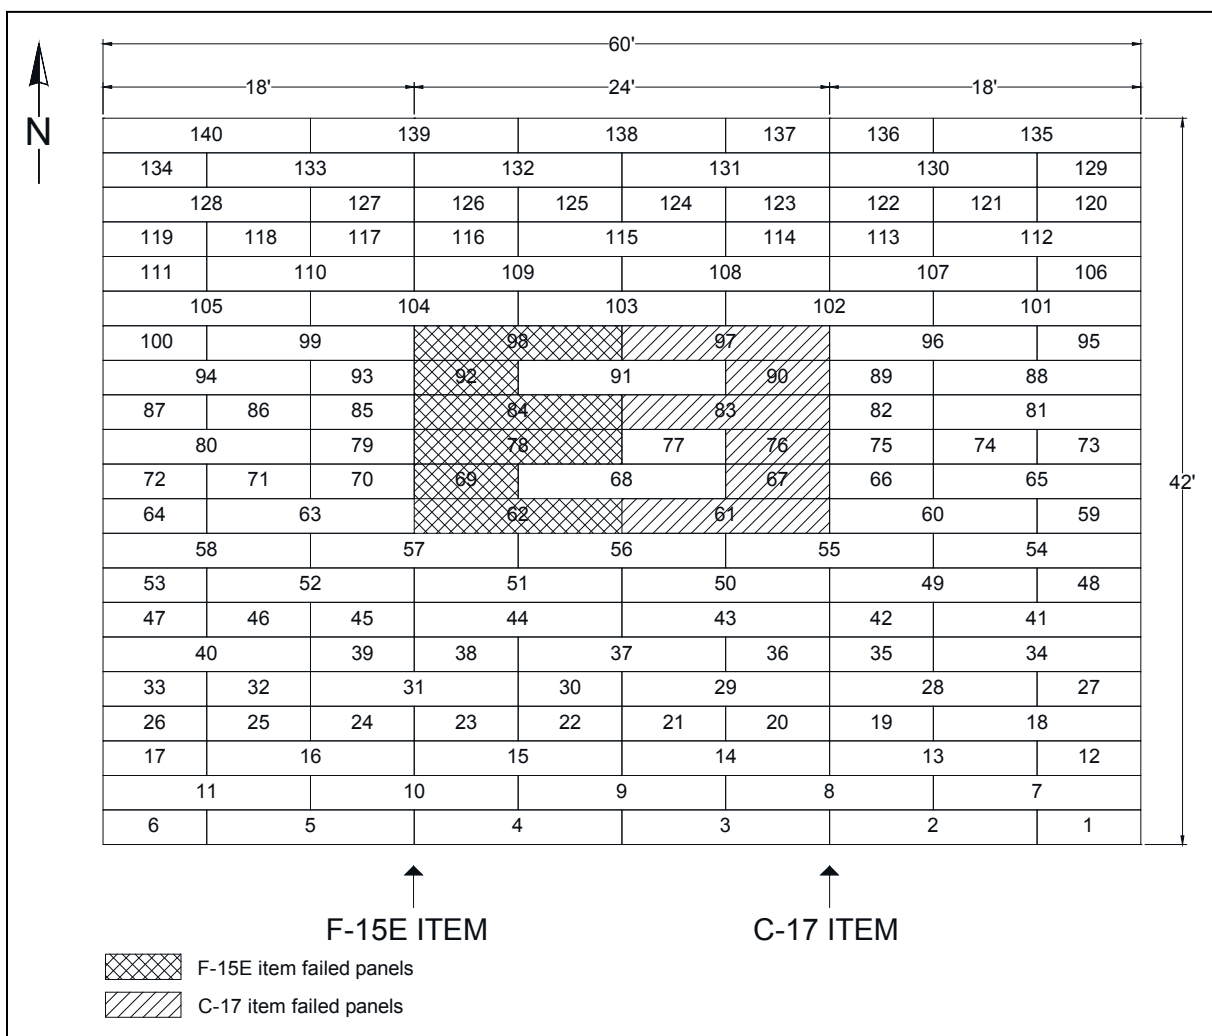
Figure 34. Layout of failed panels in the F-15E and C-17 items.

When the panels were removed after trafficking was completed, no significant additional damage was noted that could not be observed from the surface. Table 7 gives a summary of mat distresses, permanent surface deformation, and failures on the mat surface at various pass levels for the F-15E item. Figure 34 shows the layout of failed panels for the F-15E item after trafficking concluded.

Upon removal of the panels from the test section, the lower overlap of Panel 97 was also broken, and the panel was failed. The only other damage was a small corner curl in the southwest corner of Panel 96. The non-instrumented panels, 14, 20, 29, 36, 43, and 50, installed in a similar arrangement as the failed panels were not damaged. Table 8 gives a summary of mat distresses, permanent surface deformation, and failures on the mat surface at various pass levels for the C-17 item. Figure 34 shows the layout of failed panels for the C-17 item after trafficking concluded.

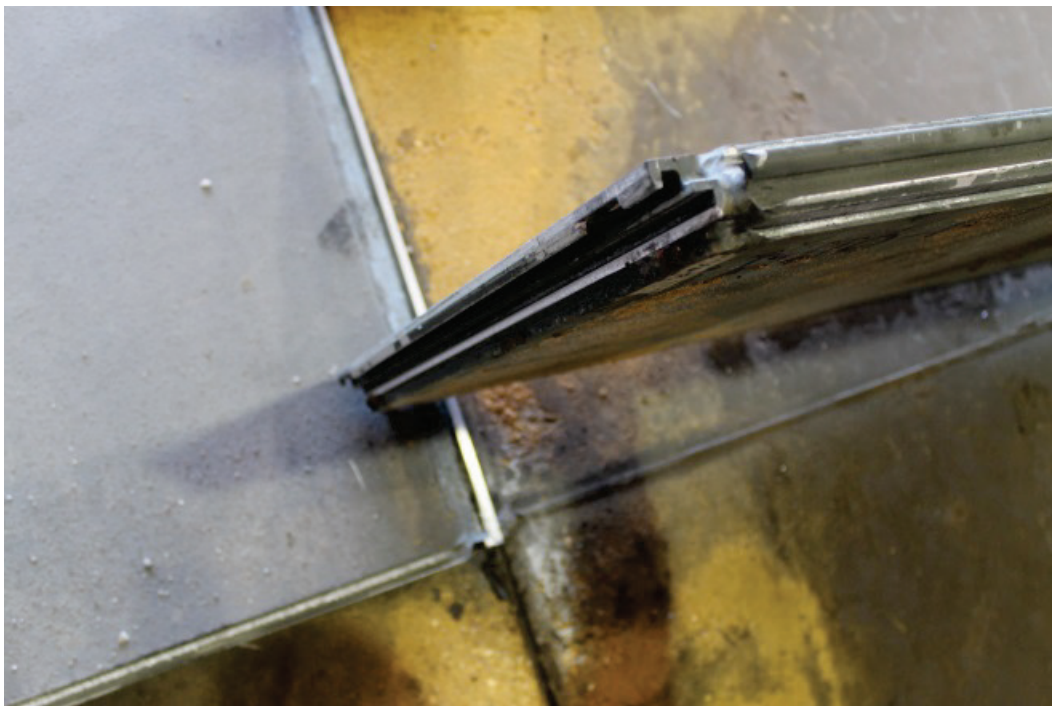
Figure 35. Typical broken lower overlap rail on C-17 item.

Trafficking of the C-17 test item over a subgrade with a CBR of 6 began on May 13, 2013. Instrumented panels began to fail quickly along the area with six continuous longitudinal joints. After 28 passes, the lower overlap

broke free from Panel 90, as shown in Figure 35, causing a tire hazard, thus failing the panel. The lower overlap broke from Panel 83 after 46 passes. The trend continued, and the lower overlaps broke from Panels 61, 67, and 76 after 50 passes. When 56 passes were completed, trafficking was stopped, because the failed panels had become a serious threat to the aircraft tires of the test vehicle. The mats were completely separating along the failed joints and were embedding into the subgrade beneath them. Even though the 10% mat breakage failure criteria had not been reached, the section was no longer usable, and total failure was eminent.
